BMW E60 LCI Dynamic Cruise Control Retrofit S544A

INTRODUCTION

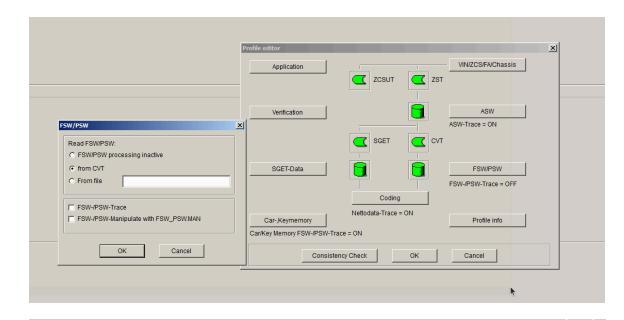
- Open NCSExpert and load an Expert profile (Manipulation must be disabled)

SW/PSW	×
Read FSW/PSW:	
C FSW/PSW processing inactive	
from CVT	
C From file	_
FSW-/PSW-Trace	
FSW-/PSW-Manipulate with FSW_PSW.MAN

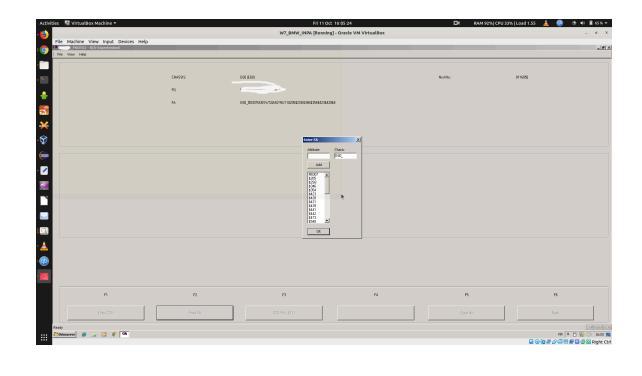
- Step 1: Read the car using CAS ECU.
- Step 2: Choose Job '*Enter FA*' and enter the option *\$544* in the Attribute field and click 'Add'.
- Step 3: Once done, click OK and click 'back' and change Job to 'FA_write', hence execute the job. Repeat this process (Step 3) for LMA ECU, by changing ECU from CAS to LMA and executing 'FA_write' job.

Enter FA Attribute:		Chasis: E60_	×	
Add				
#0307 \$205 \$25B \$346 \$354 \$423 \$428		•		
\$431 \$439 \$441 \$442 \$473 \$548	•			
ОК

Up to this stage, the Option S544A was written to both ECUs CAS and LMA. INFO: CAS ECU contains VO information. (Vehicle Order) which is redundant onto LMA Ecu.
